## The 2014 Cadillac ELR

## TECHLINK

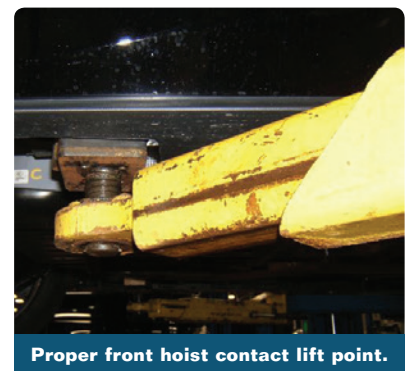
A low profile lift arms system may be required to avoid unwanted contact with the vehicle's body and structure depending on the lifting equipment being used. Refer to the hoist manufacturer's recommendation.

Proper front hoist contact lift point.

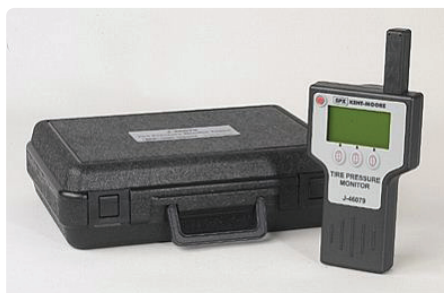
**J-46079 TPM Tester**

If dashes (---) are displayed in only one or two of the tire pressure readouts, it is likely caused by a previous TPM system relearn that was performed incorrectly due to interference from another vehicle's TPM system during the relearn process. Each tire monitor sensor is learned to a

specific vehicle corner. When performing a TPM relearn (only after a tire rotation or replacement of a TPM sensor or module), use a scan tool (GDS 2 or the Tech 2), the J-46079 TPM Tester or the EL-50448 TPM Activation Tool to initiate the relearn process and lock out other vehicle TPM signals that may be broadcasting in the area. This method avoids storing false TPM I.D.s and will prevent vehicles from returning with dashes displayed in the tire pressure readouts and/or a flashing low tire light. Check the four TPM I.D.s with a scan tool prior to and following the relearn procedure to verify they are the same.
